Icing Management for Coast Guard Assets

Charles C. Ryerson

April 2013

Final report

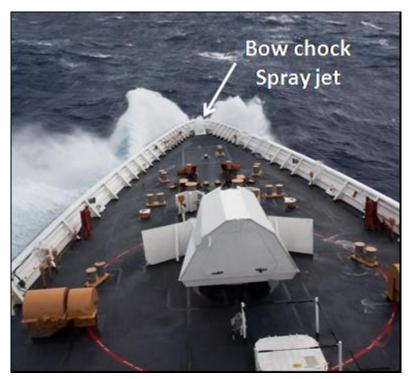
Figure 3-2. Initial plunging of NSC WAESCHE bow in 35- to 40-kt (18-to 20-m/s) winds and 3.5- to 6-m seas with a ship speed of 18 kt (9 m/s) during Tropical Depression Haikui. The beginning of a spray jet is entering the forecastle through the bow chock (courtesy LCDR Reid, CGC WAESCHE 2012).

Though bow spray is the most significant source of spray for superstructure icing, spray does reach the ship from other mechanisms. Water enters the forecastle deck area by falling over the bulwarks, and by passing through chocks through the bulwarks and through the anchor hawse pipes (Fig. 3-2). This water contributes to the initial spray plume as it jets through the openings and into the air. However, the spray event also floods the forecastle, and if the forecastle is constructed to allow water to drain off the sides of the deck, or through scuppers, that water can also be entrained by wind flow and carried over the ship (Fig. 3-3). Though not measured, it is believed that the liquid water content, drop sizes, and drop concentrations of these secondary events are small and contribute little to icing.

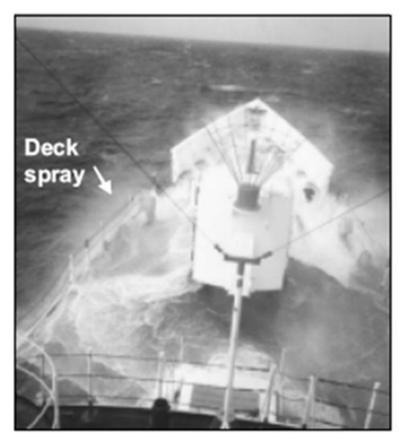
Figure 3-3. Water flowing from flooded forecastle on CGC MIDGETT and drops being entrained in wind after bow spray event in Bering Sea (Ryerson 1990).

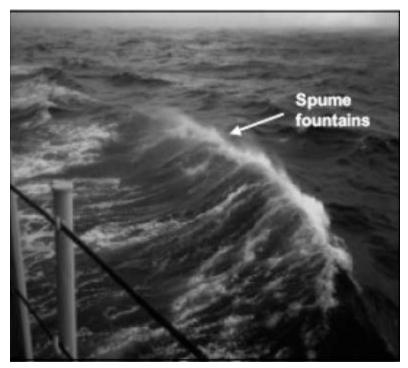
Ryerson (Ryerson and Gow 2000a, b) observed a nearly continuous spraying of surfaces on the port side of the CGC MIDGETT amidships when the bow wave over-steepened seas from port in the Bering Sea. This continuously breaking wave extending a large portion of the length of the ship was barely visible, but was felt as a continuous light mist or drizzle event (Fig. 3-4). Though liquid water content and drop sizes were small, over time it may have caused sufficient ice accumulation, had conditions been colder than about -1.8°C, to cause a thin layer of ice on decks and bulkheads.

Figure 3-4. Spume fountains midship on port side of CGC MIDGETT caused by bow wave interacting with swell from port, and breaking (Ryerson 1990).

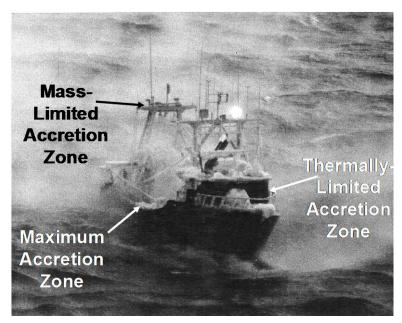
Figure 3-11. Ice accretion zones on trawler in Bering Sea, 1990 (Ryerson 1990).

Figure 3-11 illustrates a situation where thermally limited accretion is restricted primarily to portions of the bow, the forecastle deck, and the forward bulkhead of the trawler. Mass limited accretion generally occurs aft and above the maximum accretion zone because spray generally decreases with distance aft of the bow and above the main deck. The mass limited accretion zone is characterized by water delivery rates, and, thus, sensible and latent heat delivery rates, that are smaller than the atmosphere's ability to remove the heat. All of the spray (except brine concentrated within brine pockets) freezes and ice accretion is limited by available spray. It does not reach its potential thickness as determined by the atmosphere's ability to remove heat.

Mass limited accretion is most dramatically illustrated by the upper portions of the twin masts on the trawler's fantail, where ice thickness decreases with height (Fig. 3-11). The three superstructure icing zones are dynamic, with the amount of superstructure covered by each changing as spray delivery rates and patterns, and atmospheric conditions such as relative wind speed and direction, change. Thus, it is conceivable that ice may be growing on some portions of the superstructure, while on other areas it may be eroding (Ryerson 1995). In addition, depending upon ship size, spray delivery rates, and atmospheric conditions, only one, two, or all three of the zones may be found at any one time on the ship. Often, however, thermally limited accretion occurs in the bow area, transitioning to

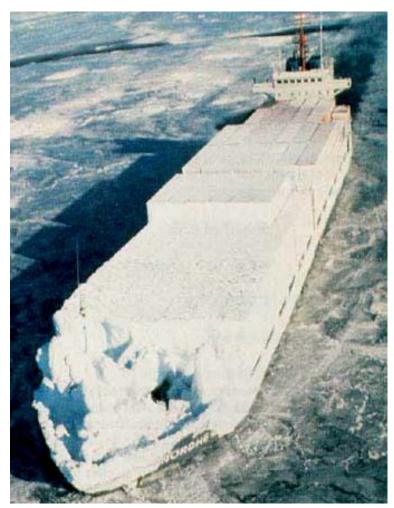
Figure 3-12. Icing of container ship. At least the forward 53 m of the ship is heavily iced from sea spray ice (from Canadian Coast Guard, http://www.qc.ec.gc.ca/meteo/secrets_stlaurent/vessel_icing_e.htm).

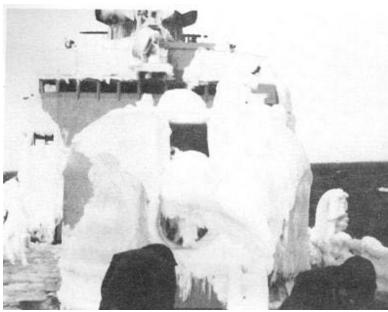
CAPT Garbe (1985) and Rogalski (1985) described icing of the USS *Capadanno*, a FFH 7 Class ship that arrived in Bath, ME, during the winter of 1981–82 with a 5° starboard list and ice at high levels on the superstructure (Fig. 3-13 to 3-18). The ship was near its load limit because of armament changes over its operational lifetime.

Figure 3-13. Front view of forward gun on USS *Capadanno* (Rogalski 1985).

Figures 3-13 to 3-18 show ice on the USS *Capodanno*'s forward gun and forecastle, rails, chocks, and anchor chain, davits, ladder and side decks.

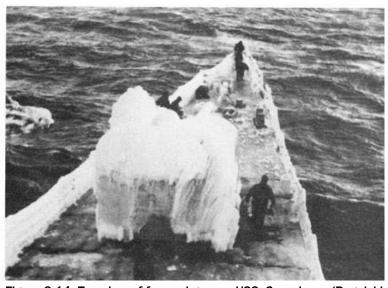
Figure 3-14. Top view of forward gun on USS *Capadanno* (Rogalski 1985).

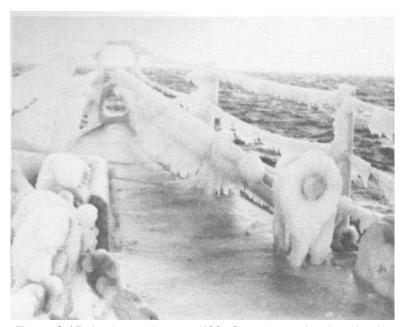
Figure 3-15. Iced over bow on USS *Capadanno* showing chocks, anchor chains, and chain hand rails (Rogalski 1985).

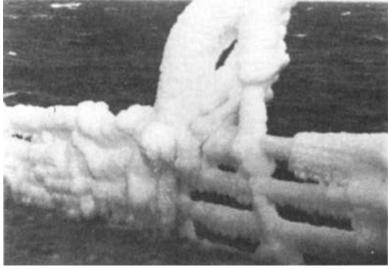
Figure 3-16. Iced over davit and chain hand rails on USS *Capadanno* (Rogalski 1985).

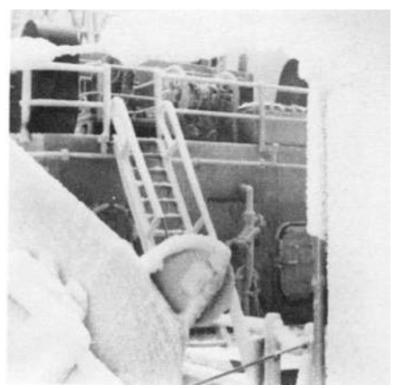
Figure 3-17. lced over ladder and deck housings on USS *Capadanno* (Rogalski 1985).

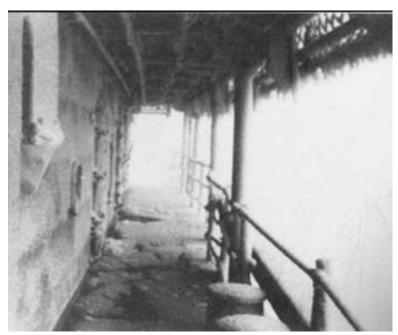
Figure 3-18. Iced over walkway on USS Capadanno (Rogalski 1985).

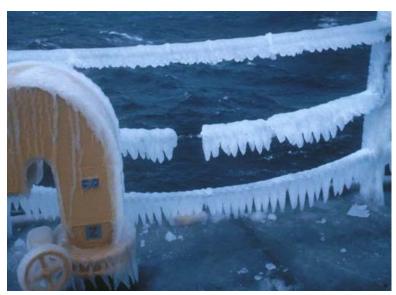
Salinity during the CGC MIDGETT's two icing events varied with surface orientation. The salinities of horizontal ice samples taken from decks and a hatch ranged from 12.0 to 24.9 ppt and averaged 21.4 ppt. Vertical ice samples were taken from bulkheads, the 5-in. gun, the lifeline, and from icicles (Fig. 3-20). These salinities ranged from 16.7 to 7.0 ppt, and averaged 12.0 ppt (Ryerson and Gow 2000a, b).

Figure 3-20. Lifeline vertical ice sample on the CGC MIDGETT (Ryerson 1990).

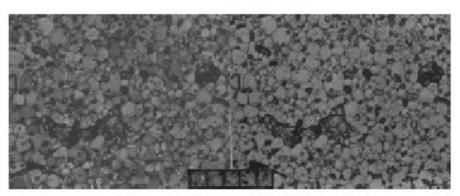
No trend towards a preferred orientation of crystallographic c-axes, either in freshly accreted ice or its aged, thermally modified (recrystallized) variant was observed. Mean grain dimensions ranged from a minimum value of 0.56 mm to a maximum of 1.15 mm (Fig. 3-21 and 3-22).

Figure 3-21. Sample taken on the forward face of the 5-in. gun mount under the barrel (scales in millimeters). Layering is strongly developed in this sample (Ryerson and Gow 2000b).

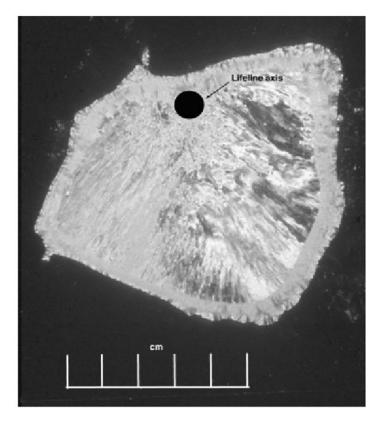
The only exceptions were one deck sample accreted in very warm weather and an icicle type ice, where the dimensions of the crystals often exceeded several millimeters and where elongation of crystals in a preferred direction was observed (Fig. 3-23). Excluding this one deck sample and the icicles, they found that the mean dimension of crystals accreted on both horizontal and vertical surfaces of the USCGC MIDGETT were similar to those measured by Tabata et al. (1963), but generally much larger than those derived from three-dimensional measurements of crystals reported by Golubev (1972).

Figure 3-23. Vertical section of icicle removed from port lifeline imaged between cross-polarizers. Note the small, round ice crystals near the lifeline, and the elongated crystals radiating away from it. The outermost layer around that sample is an artifact of mounting the sample on a glass slide (Ryerson and Gow 2000b).

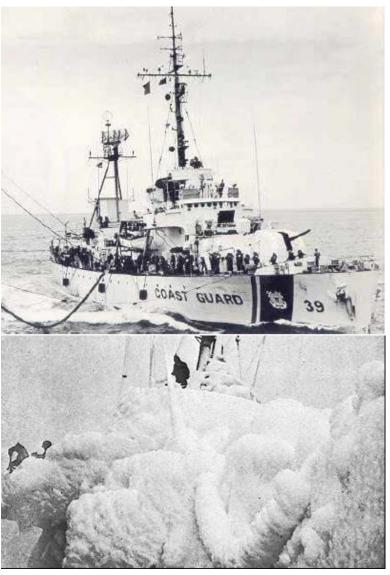
Figure 3-28. Top—CGC OWASCO (US Coast Guard 2013). Bottom—starboard side of CGC OWASCO after accumulating up to 25 cm of ice at Ocean Station "Bravo" (DeAngelis 1974).

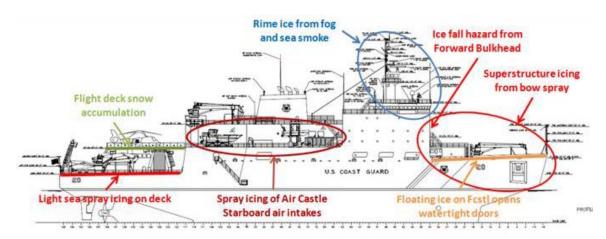
Figure 4-4 Areas of CGC HEALY with icing problems.

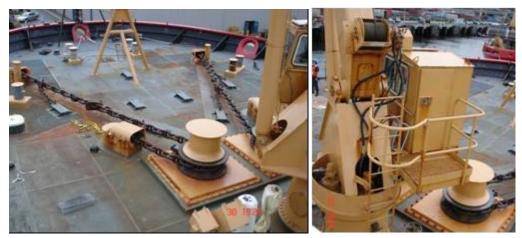
Figure 4-5. Forecastle anchor and crane hardware are made inoperable by icing (CRREL 2012).

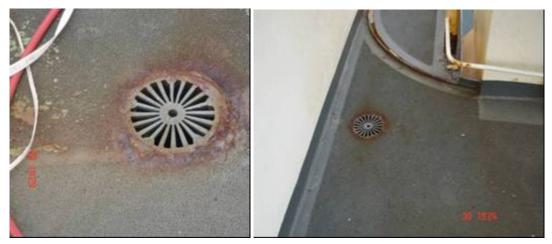
Figure 4-6. Deck drains on the forecastle and in the air castles clog due to rust and ice (CRREL 2012).

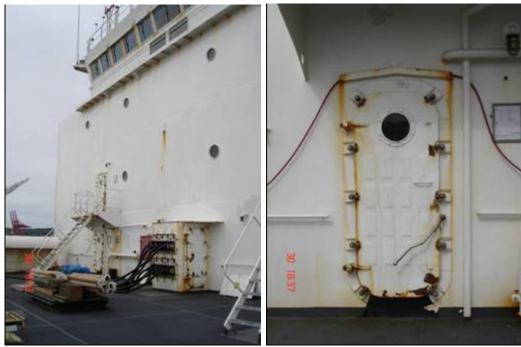
Figure 4-7. High forward bulkhead below bridge cannot be fully de-iced manually (left). Floating ice on forecastle opens watertight doors, allowing water into compartments (right) (CRREL 2012).

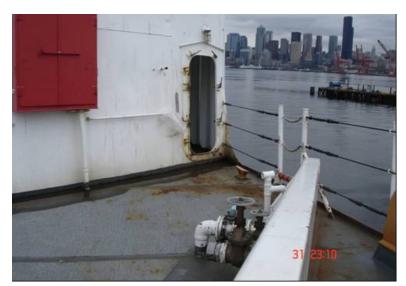
Water 1 m deep has been observed on the forecastle deck ahead of the air castle doors. This water has frozen and prevented the air castle doors from being opened, denying access to the forecastle deck. Crew members have been rappelled to the forecastle from the air castle, around the frozen doors, to remove the deck ice freezing the doors shut (Fig. 4-9).

Figure 4-9. Ice accumulates on the forecastle deck ahead of the air castle doors freezing them shut, denying access for anchoring operations (CRREL 2012).

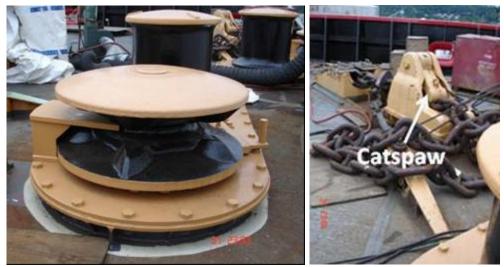
Anchoring is always done from the forecastle. If machinery and hardware that raise and lower the anchors ice up, anchoring can become dangerous, difficult, or impossible (Fig. 4-10). Anchor pockets can also ice and the 9000-lb anchor can freeze in the anchor pocket and cannot be deployed. Ice can build rapidly, and 30 to 46 cm of ice has been observed in the anchor pockets (Fig. 4-11).

Figure 4-10. Anchor hardware including wildcat on left and catspaw on right (CRREL 2012).

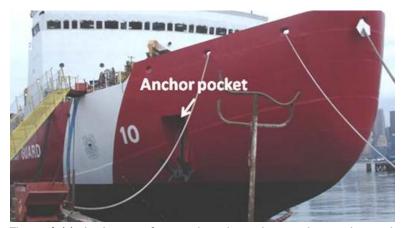
Figure 4-11. Anchor can freeze when drawn into anchor pocket and not release when required (CRREL 2012).

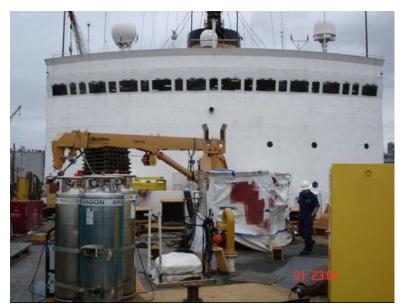
Figure 4-12. Manual de-icing techniques cannot reach high on forward bulkhead causing a falling ice hazard. Ice can also fall from the crane (CRREL 2012).

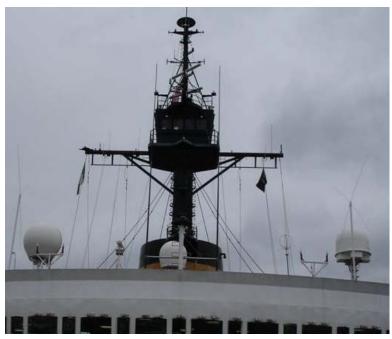
Figure 4-14. Satellite deck electronic equipment is rarely impacted by icing, but is affected by cold (CRREL 2012).

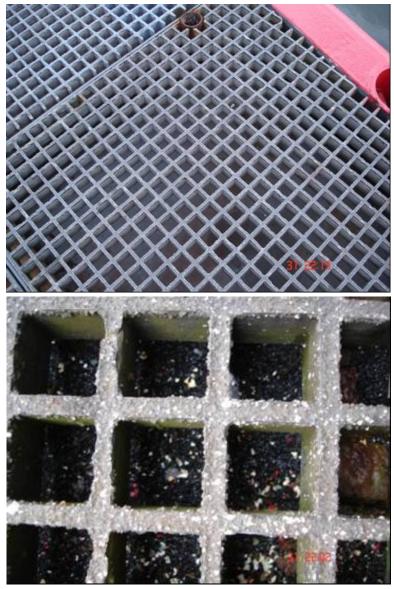
Open grid composite grating on the fantail, which reduces freezing rate, increases traction because of its grit surface, and allows ice to fall through spaces, improving safety (Fig. 4-16).

Figure 4-16. Open grid grit-covered composite grating on fantail deck improves footing and allows ice and snow to fall through (CRREL 2012).

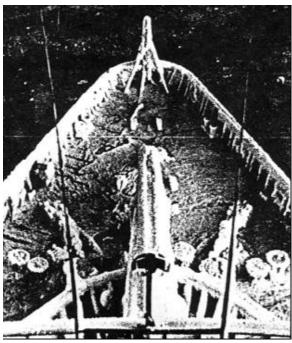
Figure 4-17. View of the CGC POLAR SEA forecastle deck 12-hours after icing ceased in February 1983 (Zahn and Voelker 1985).

On 18 February 1983 as the CGC POLAR SEA was in transit between the Aleutian Islands and ice edge in the Bering Sea in 30-40 kt (15-20 m/s) winds and 3-m seas, icing started. Temperatures fell to -11.2°C, seas rose to 4.3 m, and icing continued for 34 hours. Accumulations of 15 cm were common on all surfaces including railings, and 30 cm accumulated on the forward cargo crane. Less ice accumulated on the 02 and 03 levels, illustrating that icing decreases with height.

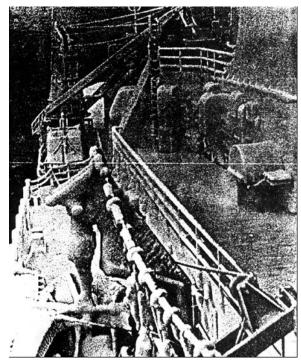
Figure 4-18. Icing of the flight deck and boats and rafts, all which are inoperative, in the February 1983 CGC POLAR SEA icing event (Zahn and Voelker 1985).

In these icing events, access to the forecastle deck was lost because of freezing of access hatches. Forecastle equipment, including windlasses, chocks, and cargo cranes, were inoperable for 3 weeks or more (Fig. 4-19). Icing of decks aft of the bridge made personnel passage treacherous and incapacitated davits and motor lifeboats.

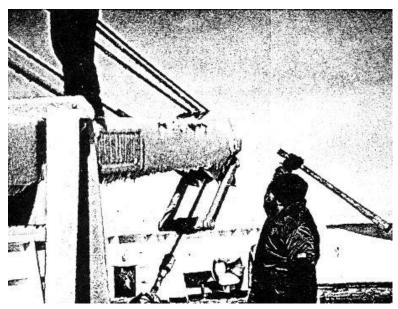
Figure 4-19. Removing ice from the forward crane, with an axe handle, on the CGC POLAR SEA in 1985 (Zahn and Voelker 1985).

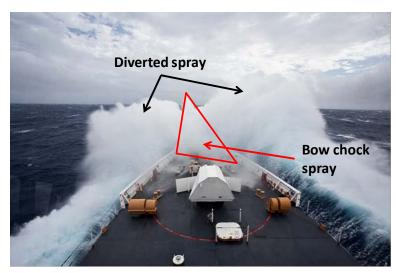
Figure 4-22. Spray diverted away from bow by flare in heavy seas. Note, however, water jetting through the bow chock and wetting the deck (courtesy LCDR Reid, CGC WAESCHE 2012).

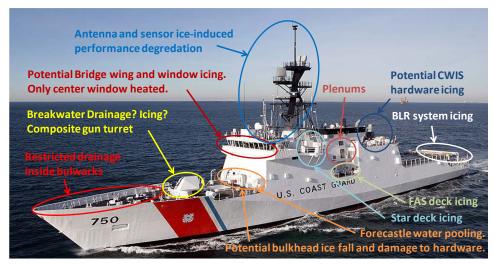
Figure 4-23. Areas of CGC WAESCHE where icing could occur and where icing could hinder operations (image from US Coast Guard).

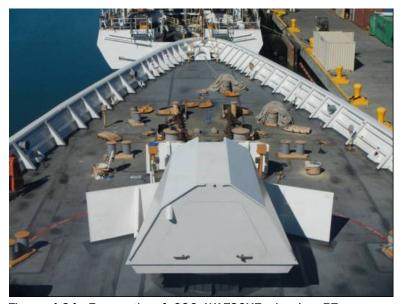
In heavy weather, sea spray covers the forecastle by flowing over the bulwarks and through the bow chock. No water enters the deck through the hawse pipes because they are well-covered at the deck level, and the anchor fits closely into the anchor pockets, reducing water entry (Fig. 4-23 and 4-24). Small drainage holes in the frames where they exit the deck and support the bulwarks are only a few inches in diameter and would likely freeze closed early in an icing event reducing deck drainage and promoting deck ice accumulation (Fig. 4-25). Forecastle deck drains are often not located at the lowest areas of the deck, occasionally protrude from the deck, and are often clogged with rust and debris (Fig. 4-26). The drains are also

Figure 4-24. Forecastle of CGC WAESCHE showing 57-mm gun (foreground), gun spray shield, anchor release and retrieval hardware, and bollards for securing lines in port or when being towed. The wall around the perimeter of the forecastle deck is the bulwarks, which reduces spray on the deck (Ryerson 2012).

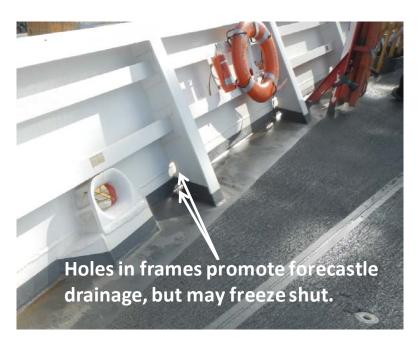
Figure 4-25. Holes in frames promote deck drainage—but may freeze shut (Ryerson 2012).

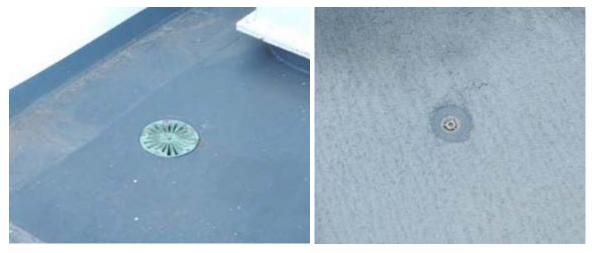
Figure 4.26. Deck drains are often not located in the lowest areas of the deck, they are often clogged with rust and construction debris, and are routed through cold areas that can cause freezing (left). Countermeasure wash-down deck nozzles could freeze, but are not expected to be needed in cold weather (right) (Ryerson 2012).

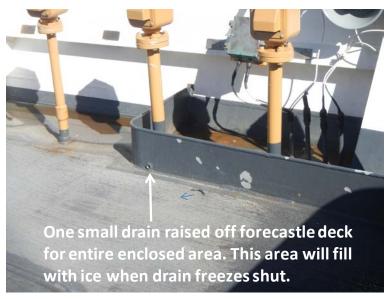
An enclosed area protecting piping and wires exiting the deck on the aft end of starboard bulwark has one small drain located at the high end and

raised off of the deck. This will flood and freeze and ice removal will be difficult (Fig. 4-27). This problem has also been observed on the JUNIPER-Class buoy tenders.

Figure 4-27. Enclosed area at aft end of starboard forecastle with one small drain that can freeze closed (Ryerson 2012).

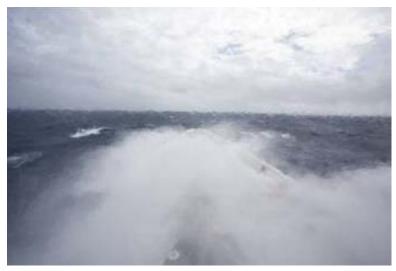
The CGC WAESCHE has operated in heavy seas during Tropical Depression Haikui. When operating in 5.5- to 6.1-m seas and 35- to 40-kt (18.9-to 20.4-m/s) winds, and cruising at 18 kt (9.2 m/s), bow spray reached the bridge windows (Fig. 4-28). This suggests that, because the bridge is atop the high forward bulkhead, that the entire face of the bulkhead could ice. It would be possible to manually de-ice only the lower portion of the bulkhead because the higher portions are not accessible except via a pipe walkway that could be too ice-covered for safe use (Fig. 4-29).

Figure 4-28. Bow spray striking bridge window in Tropical Depression Haikui (courtesy LCDR Reid, CGC WAESCHE).

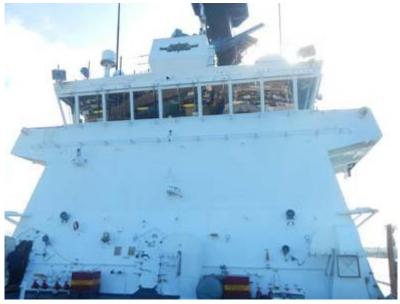
Figure 4-29. Spray reaches bridge in storms. Ice on high forward bulkhead could fall and damage antennas on bulkhead sides, and valves, wires and small piping lower on bulkhead (Ryerson 2012).

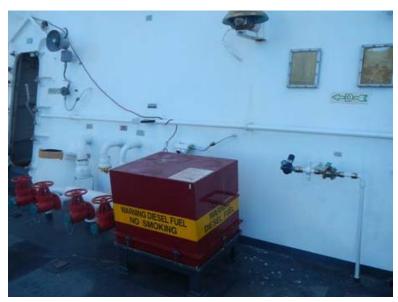
Figure 4-30. Bell and bullhorn cabling, and fire stanchion valves, could be damaged by ice falling from the forward bulkhead (Ryerson 2012).

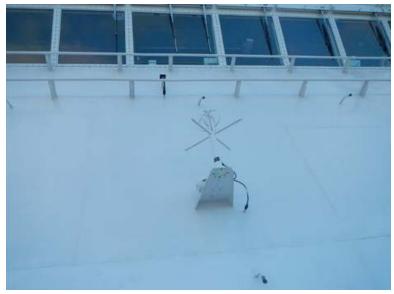
Because the high forward bulkhead precludes manual ice removal, falling ice could damage antennas positioned under the bridge wing corners (Fig. 4-29). Bullhorn and bell wiring, and fire stanchion valves at the bulkhead base, could be damaged as ice falls from above (Fig. 4-30). In addition, ice falling from the forward bulkhead could damage countermeasure washdown piping exiting the bulkhead and an antenna mounted on the bulkhead, and ice could coat the antenna, decreasing its sensitivity (Fig. 4-31).

Figure 4-31. Antennas and countermeasure wash-down piping could be damaged by ice falling from the forward bulkhead. Also, antenna performance could be reduced by ice (Ryerson 2012).

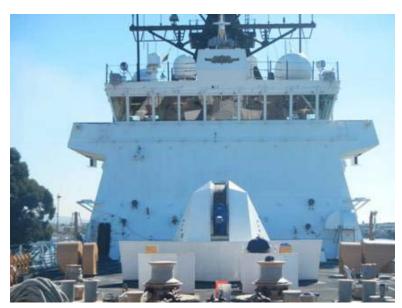
Figure 4-32. The 57-mm gun turret is a composite structure and could be damaged by manual de-icing. The spray shield below and forward of the gun may accumulate ice at its base and hinder forecastle deck drainage (Ryerson 2012).

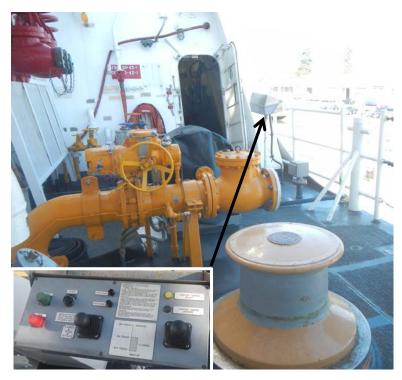
Figure 4-33. The boat deck has considerable hardware, operations involve several personnel, the area receives spray, and icing is expected. Inset shows single davit control station, and arrow shows control station location—on a deck that may be iced (Ryerson 2012).

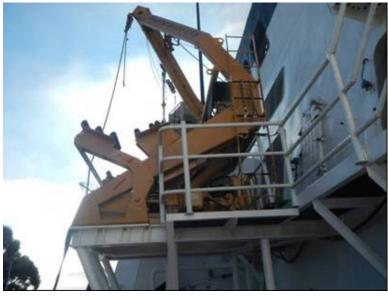
Figure 4-34. Single davit for launching boat, located one level above boat deck. It is understood that little spray reaches this height, but it is a complex machine that is difficult to keep operating fully in less severe conditions than icing (Ryerson 2012).

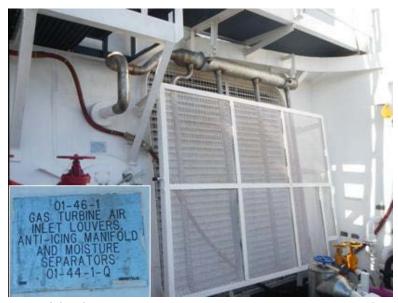
Figure 4-35. Gas turbine air intake on boat deck. A heated manifold behind the FOD screen is intended to keep the intake louvers deiced. It is not clear how the FOD screen is de-iced (Ryerson 2012).

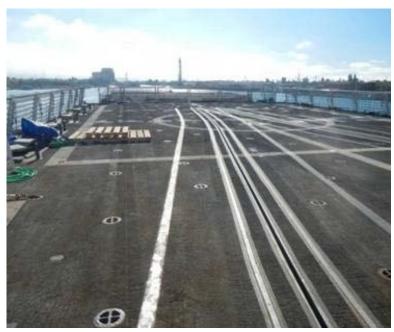
Figure 4-36. Track for guiding helicopters into and out of hangar has not been used, and will be removed. Ice from spray or snow would hinder operation of the system if it were used. Note numerous tie downs in deck that fill with water and could become unusable when frozen (Ryerson 2012).

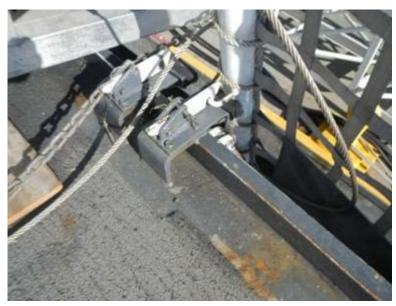
Figure 4-37. Latches for flight ops rescue team nets involve pulling pins that could freeze, making removal difficult (US Coast Guard 2012).

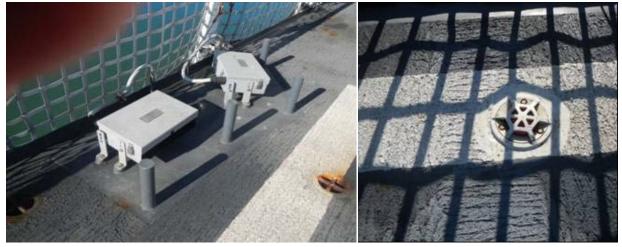
Figure 4-38. Electronic gear and cabling on flight deck could be damaged by snow shoveling. Snow or ice must be removed with care around non-glare landing zone lights for them to be useful (US Coast Guard 2012).

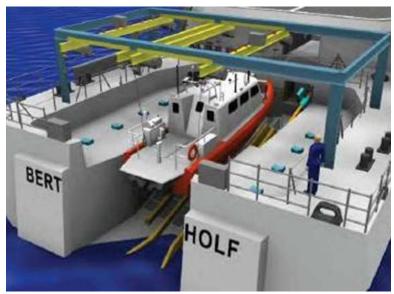
A system that may be significantly compromised by Arctic conditions is the Boat Launch and Recovery (BLR) System in the stern (Fig. 4-39 and 4-40). The system uses a ramp with low friction runners and a winch to launch and recover boats. The lower portion of the ramp, a well at the stern, is always awash so that the boat can enter or depart the stern under power and afloat (Fig. 4-41). Grid mesh walkways on either side of the runners allow footing for personnel ingress and egress. Hydraulic doors close the back of the ramp when the boat is inside, but do not make the

ramp well area watertight. Water within the well rises and falls with ship displacement changes—especially in heavy weather with ship heave, pitch, and roll. Cold weather will cause ice to form on all surfaces within the well and ramp area that are awash. This will cause slippery conditions for crew ingress and egress, and could cause launch difficulties if the boat freezes in place. It could cause recovery difficulties if the ramp becomes ice-covered when the boat is away. In addition, splashing of the clamshell doors in the closed or open position could cause ice to accumulate on the doors, or on the transom, hindering door operation. Ice on the transom could prevent the doors from opening or closing (Fig. 4-42).

Figure 4-39. The Boat Launch and Recovery System consists of a launch and recovery well and ramp, a winching system, a door system to close the stern, and an overhead crane system for transporting boats to and from cradles (diagram from The *TCG Pulse*, Winter 2011, pages 2-5).

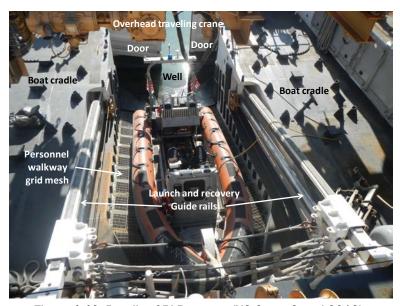
Figure 4-40. Details of BLR system (US Coast Guard 2012).

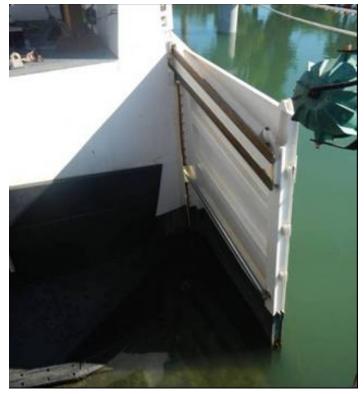
Water in the lower ramp well could freeze in extremely cold conditions (Fig. 4-41). That ice could hinder boat launching, and door opening. If operating in an area with brash ice, the boat could push ice into the well, hindering recovery. Also, ice could jam in the well area causing door closing difficulties. It could be dangerous for personnel to enter the ramp or well area to clear ice because they could slip into the well. The clutter of equipment on deck will make de-icing difficult. However, heat leaking into the area from surrounding mechanical areas may help keep the area deiced.

Figure 4-41. Starboard door of BLR system (US Coast Guard 2012).

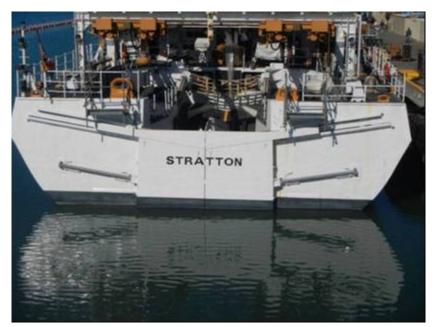
Figure 4-42. Details of BLR System stern doors and vulnerable hydraulic door slides and cylinder mechanism outside transom on NSC STRATTON (Ryerson 2012).

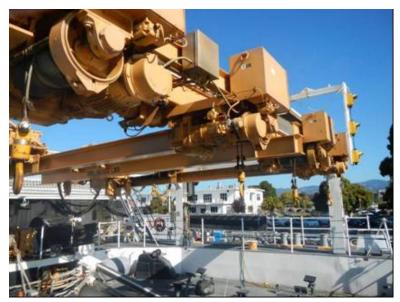
An overhead traveling crane system moves boats to storage cradles port and starboard of the ramp well (Fig. 4-43). The overhead crane is a system of exposed rails, racks and gears, winches, cables, and electronics. Spray icing from slamming of the stern could cause difficulties with crane operation. It is not protected from spray and weather elements. It is expected to be replaced with one or two single point davits.

Figure 4-43. BLR system overhead crane (US Coast Guard 2012).

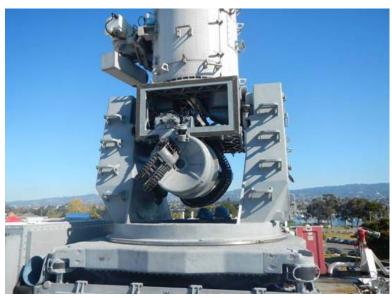
Located above the port hangar is the Close-in Weapon System (CWIS), or Phalanx Gatling gun, co-located with flight control instrumentation for the flight deck (Fig. 4-44). The photo shows a cover removed, above the ammunition feed barrel, which is replaced at sea. However, it also shows ammunition belts where rounds are fed from the magazine to the gun. If sufficient spray occurred in the area, or snow, or freezing rain, the system may malfunction because of ice-induced jamming.

Figure 4-44. CWIS system is located on the port side on top of hangar. Exposed ammunition belts that feed rounds from barrel below gun could jam in icing conditions (Ryerson 2012).

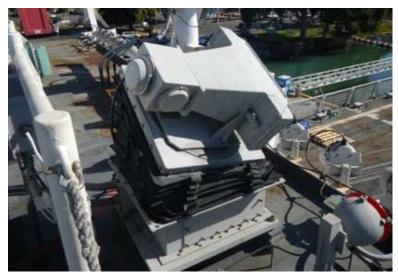
Figure 4-45. Visual approach slope indicator for helicopter landings on flight deck. Bellows icing could hinder movement or puncture bellows (Ryerson 2012).

Also, the helicopter landing aid system, located below the CWIS, could have movement hindered by ice and sustain damage to the bellows (Fig. 4-45).

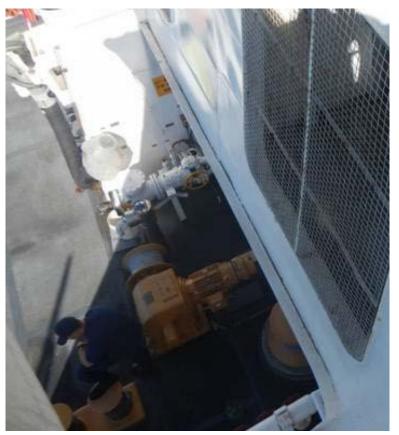
Figure 4-46. FAS deck with piping, winches and hardware that could ice, according to crew, and hinder fueling when underway (US Coast Guard 2012).

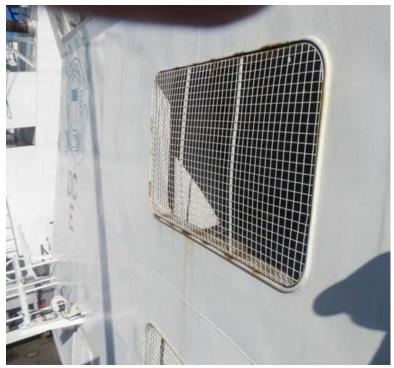
The Fueling-at-Sea (FAS) deck on the port side could ice from spray or snow. Piping and winches must be kept clear of ice to allow fueling when underway (Fig. 4-46). Plenum screens above FAS deck on port side are not of serious concern (Fig. 4-47). It is assumed that they are exhaust vents, or low-velocity inlets, because they have no heating system nor FOD screens.

Figure 4-47. Plenum screens above FAS deck on port side. It is assumed that they are exhaust vents because they do not have FOD screens or heating systems (Ryerson 2012).

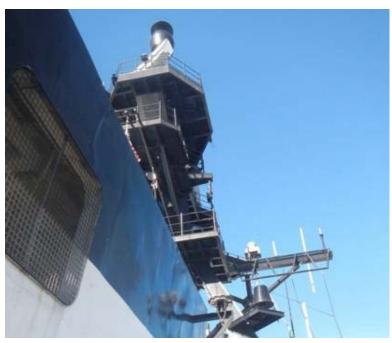
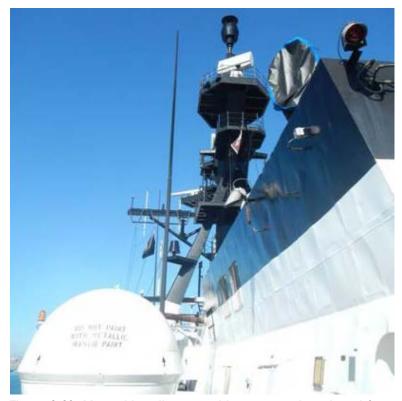
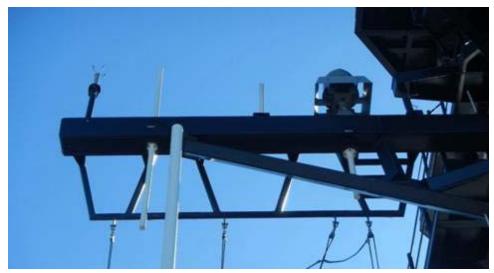
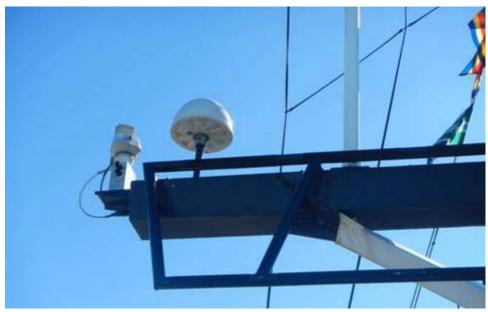
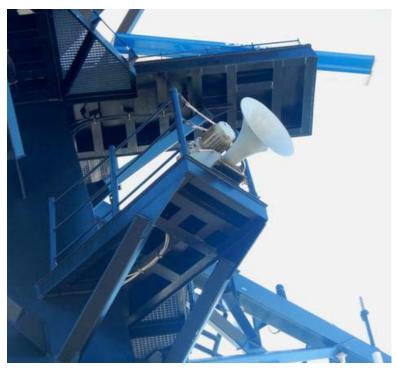
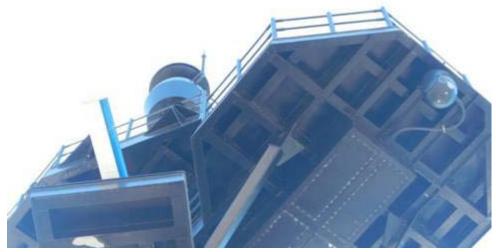
NSCs are configured as command and control centers. Therefore, they have a CIC and a SCIF that use tracking and communication systems requiring numerous antennas and sensors above the bridge and on the mast (Fig. 4-48–4-53). This capability must be protected for SAR and other activities because sea spray has been observed to reach the mast and bridge wings. In addition, atmospheric icing in the form of rime and glaze from freezing rain could reduce the effectiveness of antennas, optics, and associated equipment.

Part of the NSC's mission is command and control through the SCIF and CIC. This capability requires antennas, radars, Forward Looking Infrared imagers (FLIR), and other sensors and antenna systems that must operate under all conditions. Saline ice accumulation on instruments, and antennas, and meteorological gear on the mast could cause loss of capability through decreased sensitivity or complete loss of the instruments. This equipment is important for mission success and safety, including navigation capability.

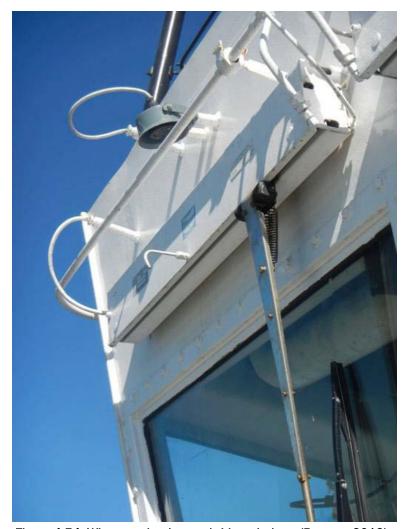
Figure 4-54. Wiper mechanism on bridge windows (Ryerson 2012).

Bridge window wipers could freeze in place if not operated during icing conditions (Fig. 4-54). Only the front middle window is heated on the entire bridge.

Bow generated spray readily reaches the bridge windows in heavy weather. Though all bridge windows have wipers and washers, only the center window is heated. Therefore, the bridge windows will ice over in freezing spray conditions, and wipers may freeze in place. Ice-free bridge windows are of high priority on most cutters.

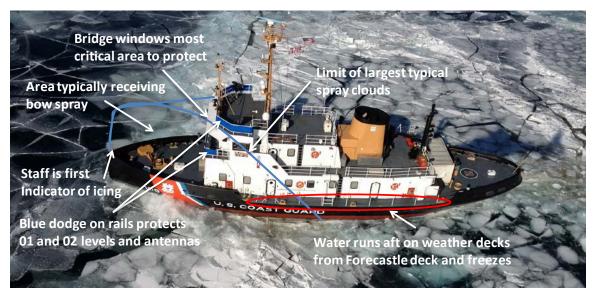
Spray and ice have been observed as high as the flying bridge on the CGC THUNDER BAY, though usually not higher. Spray typically tapers off towards the stern as shown with the blue lines in Figure 4-56. More pronounced bow flare might deflect spray away from the ship and reduce icing, as might a spray deflector on the bow. A blue dodge (tarp) is placed on the railings on the 01 and 02 levels above the forward bulkhead to protect bridge windows, and antennas, Global Positioning System (GPS), and navigation systems above the bridge. Ice adheres to the dodges in morning, but the sun quickly warms them and the ice falls off (Fig. 4-55 and 4-56).

Figure 4-56. Locations of spray and icing characteristics on the CGC THUNDER BAY (US Coast Guard, n.d.).

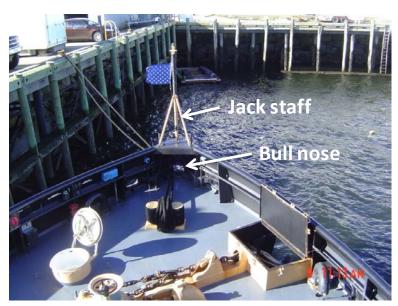
Figure 4-57 Initial icing is observed on jack staff, in bull nose, and on sides of hull (CRREL 2012).

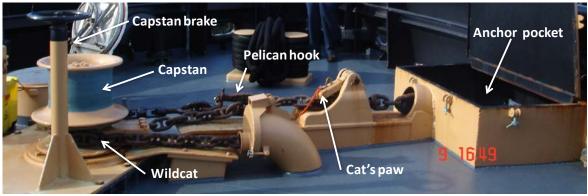
Figure 4-58. Anchor hardware that ices on the forecastle deck (CRREL 2012).

Generally, the sides of the hull, the bull nose, and the Jack staff ice on the forecastle first. The Jack staff is typically watched as an indicator; it is usually the first sign of icing (Fig. 4-57). Also, the anchor cannot be released until its hardware is de-iced. Anchor chain wound around the wild-

cat freezes, and the actual anchor freezes in place (Fig. 4-58). The cats paw and pelican hook both ice and must be de-iced for anchor use. Anchor detail is a high safety issue owing to frequent navigation of the ship in proximity to shoal water. Mooring is also difficult when equipment is iced because of deck ice, iced chocks, and iced bits. Hammers are used to de-ice the chocks when they occasionally freeze.

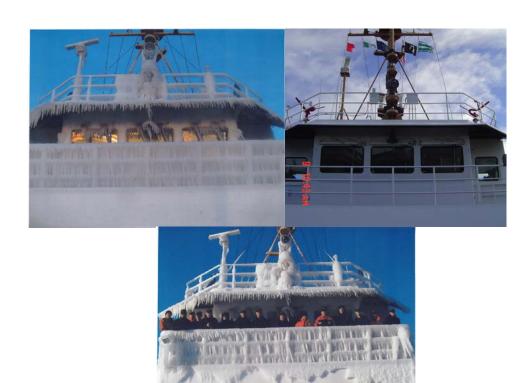
Figure 4-59. Iced bridge and flying bridge on CGC BISCAYNE BAY in Lake Superior (upper left). Ice free bridge and flying bridge on CGC THUNDER BAY for comparison (upper right). Bottom image shows height to which de-icing can occur from the forecastle deck. (CGC BISCAYNE BAY photos courtesy LCDR Godwin, USCG; CGC THUNDER BAY photos by CRREL 2012).

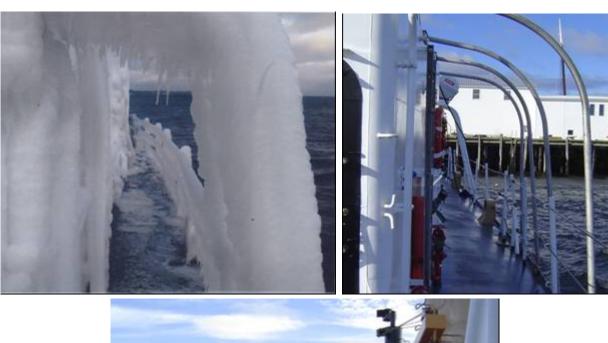
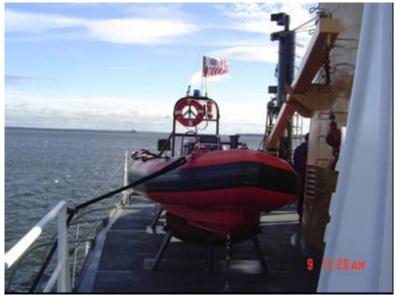
Spray reaches as far aft as the boat deck on the main deck, sometimes allowing several inches of ice to accumulate (Fig. 4-62). Icing prevents boat launching from the starboard 01 level boat deck, even though icing is rare on the 01 level. The main deck below the boat deck ices where crew needs to work loading or unloading the boat, and manning the painter. Handling a painter on an iced deck is extremely dangerous. Boat launches are cancelled when decks are iced except under the most extreme of circumstances. Weather decks are always secured during and after icing because crew can slip overboard under lifelines. A buddy system is used whenever personnel enter decks in icing conditions.

Figure 4-62. Icing of CGC BISCAYNE BAY in Lake Superior (upper left). Same area without ice on CGC THUNDER BAY (upper right). The cradled boat on the 01 level boat deck does not ice, and is covered by a tarp in icing conditions (bottom). (CGC BISCAYNE BAY photo courtesy LCDR Godwin, USCG; CGC THUNDER BAY photo CRREL 2012).

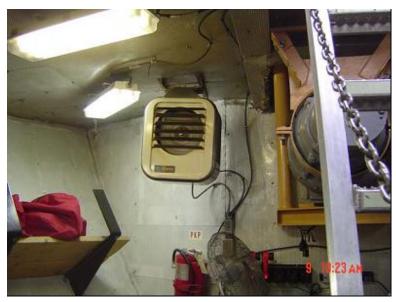
Weather deck de-icing, or anti-icing, is encouraged by the use of space heaters below deck. Space heater output is increased during icing, often making below decks uncomfortably warm, to encourage warming decks from below (Fig. 4-63).

Figure 4-63. Space heater used to heat space under forecastle deck to reduce icing and help de-icing (CRREL 2012).

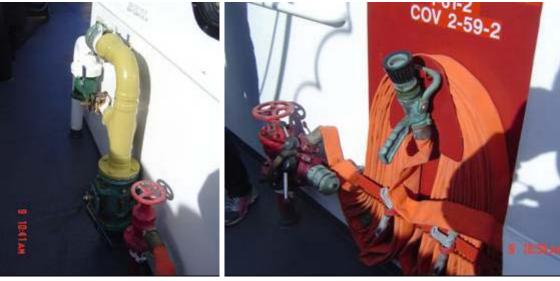
Figure 4-64. Valves and vents become ice covered forward of amidships (left image). Fire hoses are removed before winter because they freeze in place (right image) (CRREL 2012).

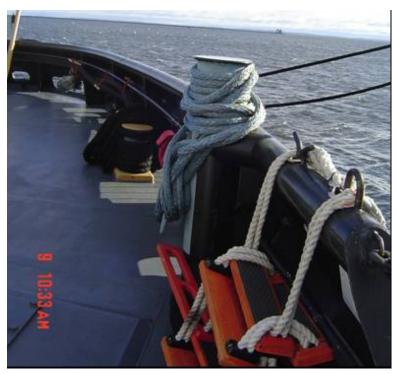
Figure 4-65. Synthetic line (wound around cleat) freezes hard; double braided line on ladder stays flexible in cold weather (CRREL 2012).

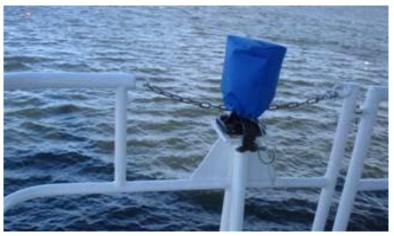
Figure 4-66. Gun mount covered with tarp to reduce icing and other weather effects (CRREL 2012).

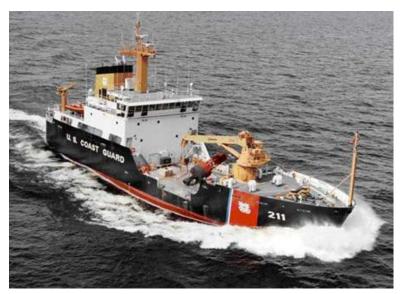
Figure 4-67. CGC OAK showing spray generated in calm seas and forecastle crane in parked position over buoy deck when underway (US Coast Guard, n.d.).

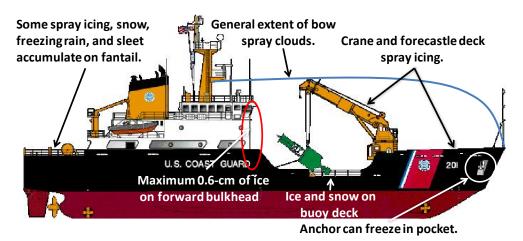
The CGC WILLOW experienced a bow spray icing event in 2010 that accumulated 5 cm of ice on the forecastle deck and hardware. Most bow spray icing occurs on the forecastle and buoy decks (Fig. 4-67–4-71). The

Figure 4-68. Ice accretion characteristics of 225-ft seagoing buoy tender GCG WILLOW and suggested ice protection (US Coast Guard, n.d.).

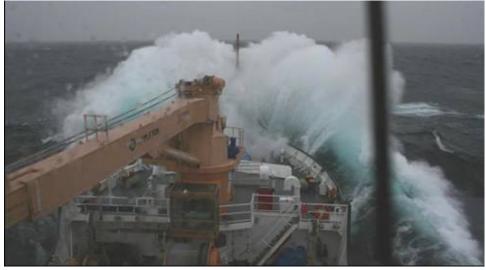
Figure 4-69. Bow plunging and spray generation on the CGC ALDER. Note the white spray shield on the deck ahead of the crane. The CGC WILLOW has no forecastle spray shield, but icing experience suggests that it is desirable (http://www.uscg.mil/d9/cgcAlder/photo_gallery.asp).

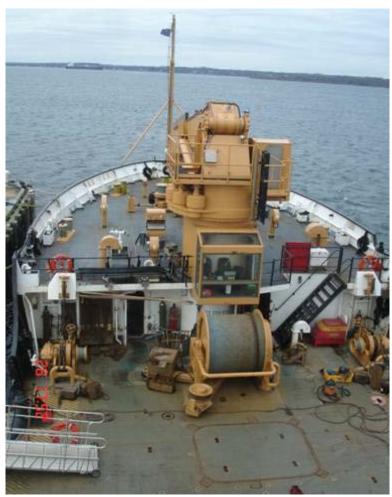
Figure 4-70. Forecastle (forward) covered with non-skid, and the zinc-covered buoy deck (aft) of the CGC WILLOW. The crane is rotated 180° when the vessel is in-transit (Ryerson 2012).

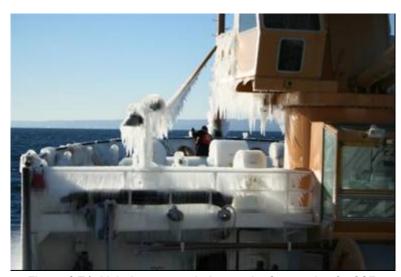
Figure 4-71. Light ice accumulation on the forecastle of a 225 (http://www.uscg.mil/d9/cgcAlder/Photo_gallery2.asp).

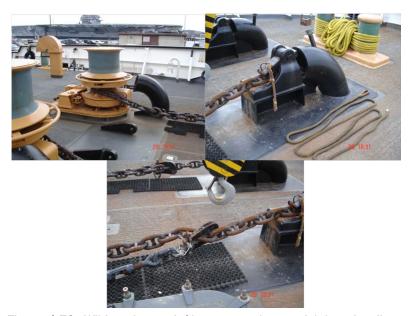
Figure 4-72. Wildcat (upper left), catspaw (upper right) and pelican hook (bottom) require de-icing before releasing anchor (Ryerson 2012).

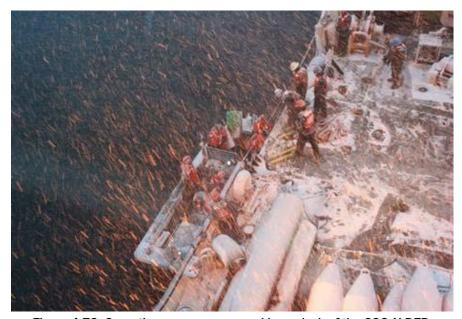
Snow is also a safety problem, and it accumulates on the vessel in port and in transit. All weather decks, including the buoy deck and flying bridge, accumulate snow. Snow has accumulated on forward bulkhead to 0.6-cm thickness. Icing is worse when spray occurs on snow. A slush and snow cover 5–7.5 cm thick is a hazard (Fig. 4-73).

Figure 4-73. Operations on snow-covered buoy deck of the CGC ALDER (http://www.uscg.mil/d9/cgcAlder/Photo_gallery2.asp).

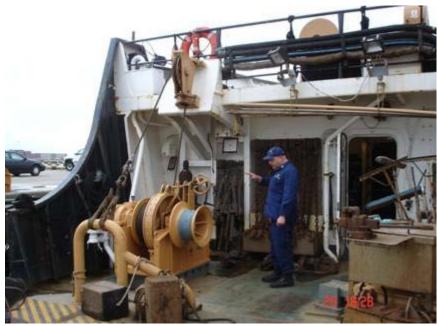
Figure 4-74. Officer indicating windlass and aft-facing bulkhead area at forward end of buoy deck that ices heavily from sea spray (Ryerson 2012).

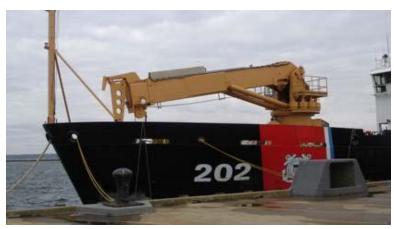
If the crane is covered with freezing rain-created glaze ice, it can be used, though ice fall is a hazard. If the crane ices with sea spray ice the ATON mission cannot be accomplished without de-icing the crane and buoy deck (Fig. 4-75). When the crane is lifting 45,000 lb from one side, the ship can list 9°, and the crew cannot operate on an iced deck with a 9° list as the buoy deck is coated with zinc, not non-skid. In addition, VERTREP is refused when underway if icing is happening because of dangerous deck conditions. Safety also decreases when drains and open scuppers are clogged by ice, and because buoy deck drains are susceptible to clogging by debris created from buoy maintenance.

Figure 4-75. Sheets of ice can fall from the crane after icing. The crane is parked over the buoy deck when in transit, 180° from view above, which makes falling ice a hazard when that deck is used before de-icing the crane (Ryerson 2012).

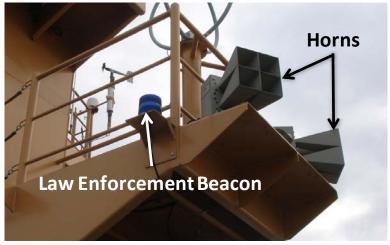
The ship's horn fails in snow, freezing rain, sleet, and spray icing, and the searchlights ice over. The mast is internally heated in cold weather, and radio and radar operation are not affected by icing (Fig. 4-76 and 4-77). In addition, incandescent lights stay de-iced from their heat. New LED lights, however, may ice over because they provide little heat (Fig. 4-76).

Figure 4.76. Incandescent Law Enforcement beacons stay deiced when in operation, but may not if converted to LEDs. Horns on mast fail in snow, freezing rain and sleet (Ryerson 2012).

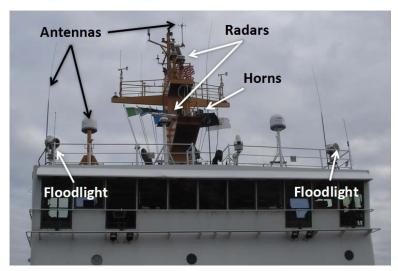
Figure 4-77. Electronics are affected by cold and must be kept running continuously. Floodlights ice over, and horns fail in icing, but radars and antennas are little affected by ice (Ryerson 2012).

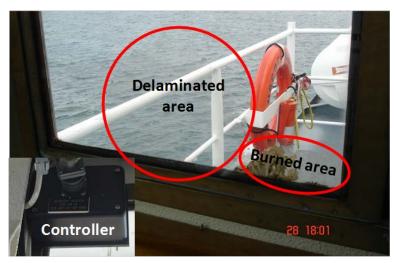
In new design, electric heating elements could be installed along the main exterior walkways, to improve safety, and on the mast, which is difficult to reach for manual ice removal. Adequate generator capacity would be needed with a thermostat to prevent burnout when conditions warm, as occurs with heated bridge windows. See Figure 4-78 as an example of heated window overheating on a *Juniper*-Class cutter.

Bridge windows are electrically heated. The heated windows and wipers are integral units (Fig. 4-78 and 4-79). When heated windows fail, it is often attributable to controller failure. Another cause of window failure occurs when the window heaters are used with no air moving across them, as when in port (Fig. 4-78).

Figure 4-78. Delaminated and burned heated window, perhaps from failed controller or from operation when cutter is stationary (Ryerson 2012).

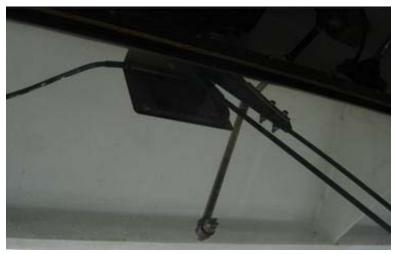
Figure 4-79. Complex window washer/wiper mechanisms freeze and fail on other cutters, but CGC WILLOW has had no problems with them because little icing occurs at the bridge as it is so high and located so far aft (Ryerson 2012).

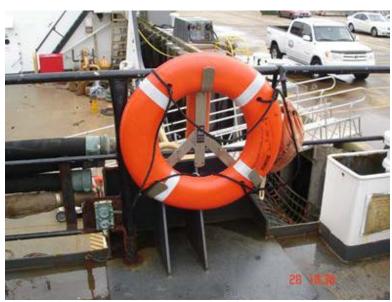
Life rings ice to the ship and must be kept free for SAR and man overboard events. Emergency position-indicating radio beacons (EPIRBS) also freeze in place; they must release automatically if the vessel sinks (Fig. 4-80 and 4-81). Hydrostatic releases on life rafts must release when submerged 0.9–1.2 m and may fail if covered with glaze or spray ice. The Navy cold weather operations manual also highlights this problem. Exterior fire stations are also drained for cold weather operations.

Figure 4-80. Life ring on aft rail of forecastle deck in area that ices heavily from spray (Ryerson 2012).

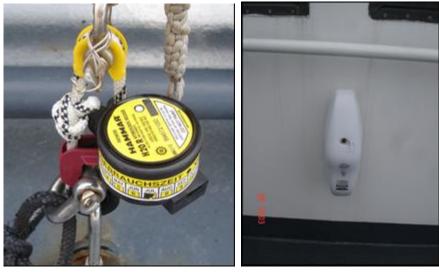
Figure 4-81. Hydrostatic life raft releases can ice and fail if vessel sinks (left), and EPIRBs can freeze in-place and not release if vessel sinks (right) (Ryerson 2012).

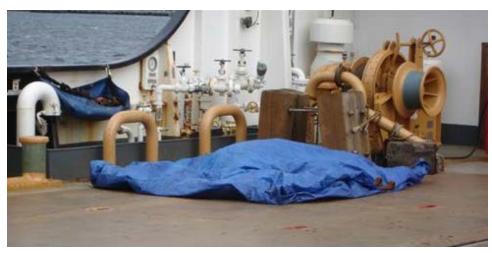
Figure 4-82. Blue tarps used for covering deck machinery (Ryerson 2012).

Most deck machinery is covered with tarps all year; they are very effective at preventing icing of hardware, and ice is easily removed from tarps (Fig. 4-82). Though the 225s have electrical space heaters, they only provide interior heat—they have not proven effective for heating decks above interior spaces as has been done with the 140-ft icebreaking tug.

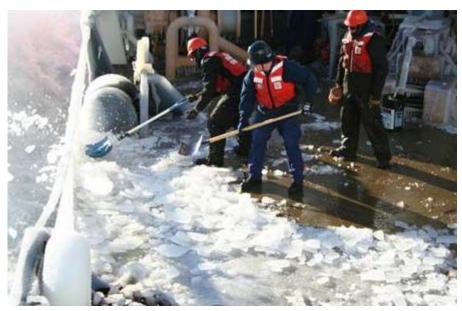
De-icing can break equipment and injure personnel. Slips, falls, and sprained ankles and wrists happen, and eye safety gear must be worn because of flying ice. Fatigue is a concern during de-icing. Ice removal is an all-hands-on-deck situation and is very difficult. Personal Protective Equipment (PPE) is vital, including cold weather gear, Carharts, mustang suits, boots, under armor, gloves, hats, balaclavas, eye goggles, and Yak Tracks or similar boot gripping systems (Fig. 4-83). Iced decks are very slippery, and crew exert themselves and sweat profusely, and then chill if they rest in the frigid conditions (Wirth 2012).

Figure 4.83. Removing about 2–5 cm of fresh-water ice from the CGC ALDER'S buoy deck using shovels and wooden mallets. Note the personal protection equipment necessary for safety

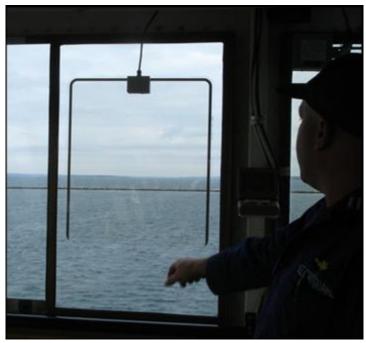
Figure 4-84. Seaclear after-market adhesive electric window heater to replace failed window heaters (Ryerson 2012).

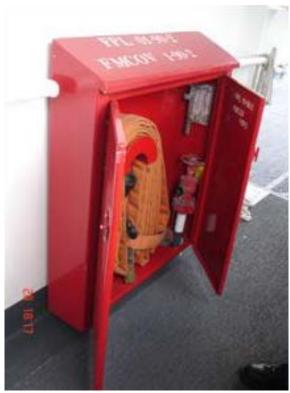
Figure 4-85. Proper metal cover for fire hose and valve on weather deck (Ryerson 2012).

Additional suggestions for improving de-icing and anti-icing on the 225s include the use of special anti-icing/de-icing materials (Durley 2012), and steam wands to rapidly remove large pieces of ice from the superstructure. Steam wands would require a low cost boiler with a dedicated steam line and hose. Steam does not introduce a large volume of water that standard pressure washers do, and they were an effective method of de-icing when ships were powered by steam (Wirth 2012). And, all fire hoses need better protection, such as tarps or metal covers (Fig. 4-85).

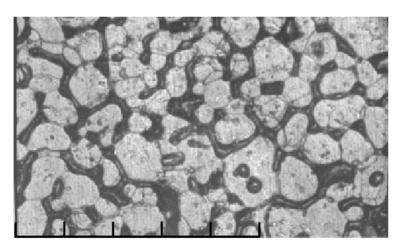
Figure 5-3. Thin section of saline ice sampled from a bulkhead on the CGC MIDGETT in March, 1990 in the Bering Sea illustrating grains (light color) encircled by large channelized networks (dark) filled with brine (scale in millimeters) (from Ryerson and Gow 1990b).

The controls of salt water adhesion are dominated by a brine layer that forms at the ice—substrate interface. As ice crystals form, they exclude impurities from the ice. Salt, as an impurity, then concentrates in unfrozen water that migrates to spaces between the ice crystals, and forms pockets of brine. These small reservoirs are initially filled with concentrated salt water, but gradually drain and fill with air, especially if they are located on an inclined surface where gravity can cause drainage (Fig. 5-3) (Ryerson and Gow 1990a). There is no ice in the brine pockets. Therefore, where
